Effects of Hydrogen Generated by Corrosion of Steel By M. H. Bartz and C. E. Rawlins	7
Effect of Atmospheric Corrosion on Maintenance and Economics of Overhead Line Hardware and Guy Strand—Part 2 By C. J. Couy	7
Organic Coatings for Corrosion Protection—A General Discussion By G. W. Seagren	9
Salt Water Corrosion of Ships By R. A. Pomfret and L. M. Mosher	7
A Message From Your Officers	x
Conference and Exhibition Resume	1
NACE Awards 8-	9
NACE News	0
Abstracts	7
Index to Advertisers	2

Effects of Hydrogen Generated By Corrosion of Steel*

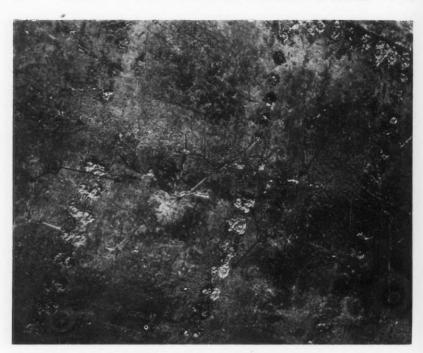
Costly corrosion troubles were encountered on the underwater hull of a cargo vessel built not long ago at one of our yards. Prior to launching, this vessel was coated with a single coat of marine primer and single coats of standard anti-corrosive and anti-fouling paints. After a fitting-out period of four months, the vessel was drydocked prior to delivery, at which time the vessel was spot primed where necessary

Figure 2—General deterioration of rivet points and shell. Rivet points (Arrows 1). White deposits (Arrows 2). Corrosion of plate away from rivets at breaks in mill scale (Arrows 3).

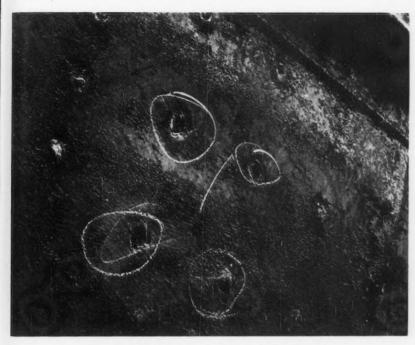
Figure 3-Enlargement of corroded rivets shown in Figure 2.

white patches of sea salts sometimes called "Cox" deposits which, when removed, disclosed mill scale beneath. Under sea water immersion, such deposits form on cathodic surfaces, hence, in the absence of externally applied currents, give telltale evidence of the presence of galvanic activity.
